FLOOD INVESTIGATION REPORT

July 28th 2014

HILLINGDON
LONDON

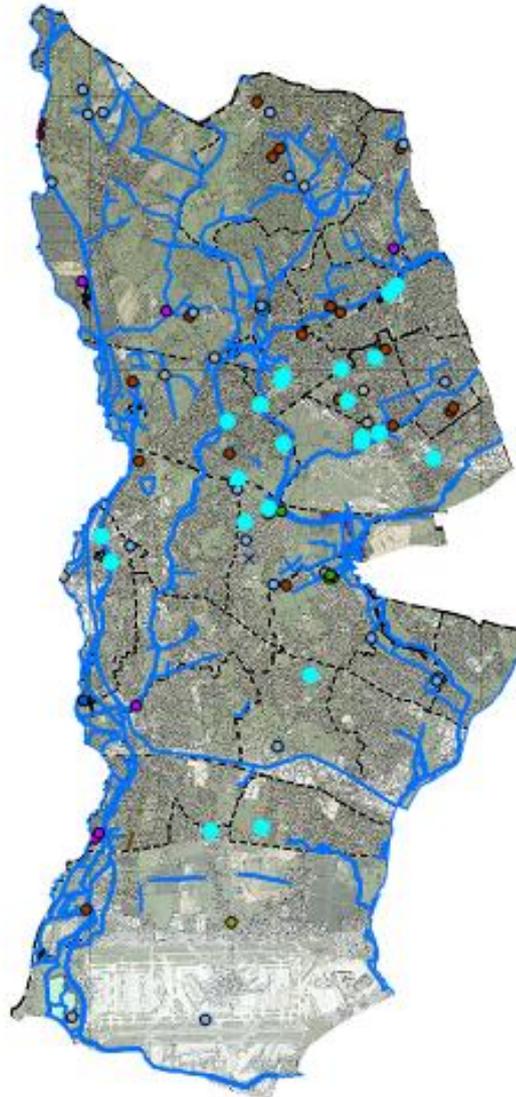
Map of Key areas affected on the 28th July.

The flooding reports were mainly from the Ruislip and Northolt Area, although there were some localised issues in Uxbridge and West Drayton. The majority of issues appear to have been due to heavy rain overwhelming surface water sewers. .

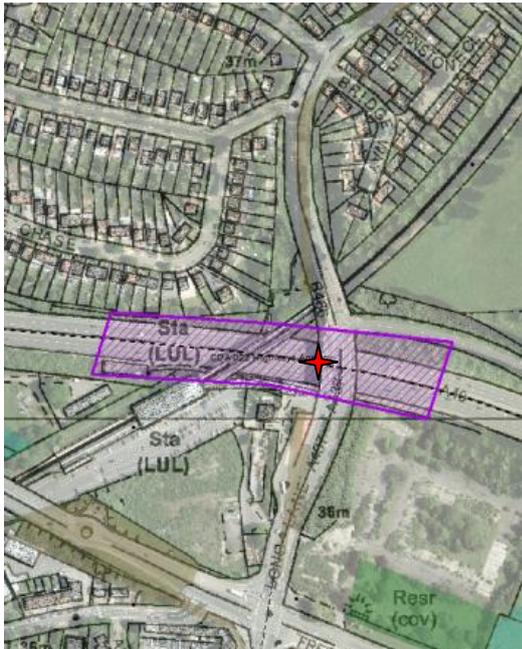
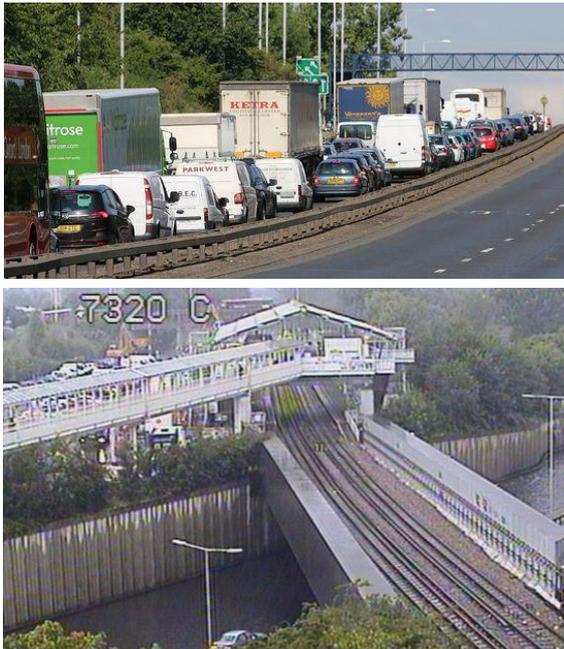
Area affected	a A40 adjacent to Hillingdon Underground Station
Date of flooding	28/07/2014
Grid Reference	507664 185051 TQ 0785SE
Land ownership	TFL responsible
Map of Area	Photo
Location of flooding marked as a red star. Critical Drainage Area in purple	Tailback on A40 due to closure, Photo of water posted by Uxbridge South police team to twitter

Duration of flooding	Approximately 12 hours
Source of flooding	Surface Water
Cause/Pathway	Heavy rain in a very short period resulted in the overwhelming of surface water drainage arrangements and water built up in low point on the A40
Impact of flooding	A40 closed, diversions and tailbacks across Hillingdon
Evidence	Photographs from a variety of sources. The area is also defined as Critical Drainage Area, within the SWMP.
History of flooding	None
Summary	Identified as an area of risk within the Hillingdon Surface Water Management Plan (2011) and published on the Hillingdon website. A copy was provided to Transport for London 22 nd Jan 2013.

Action by TFL	Investigate and determine appropriate actions and share discuss with the Council as the Lead local Flood Authority
Action by the Council	Further investigation has been undertaken by the Council working with the GLA and Drain London but no information on the drainage infrastructure in the area has been provided by TFL despite repeated information requests. The investigation undertaken by TFL has been requested by the Council on a number of occasions since the event but not yet provided.

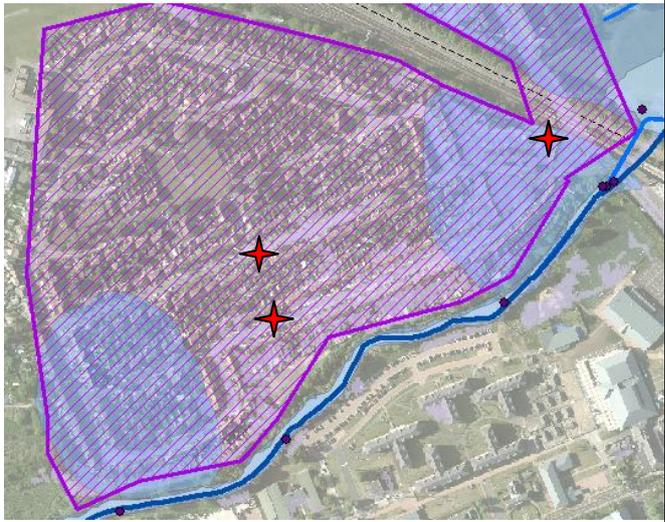
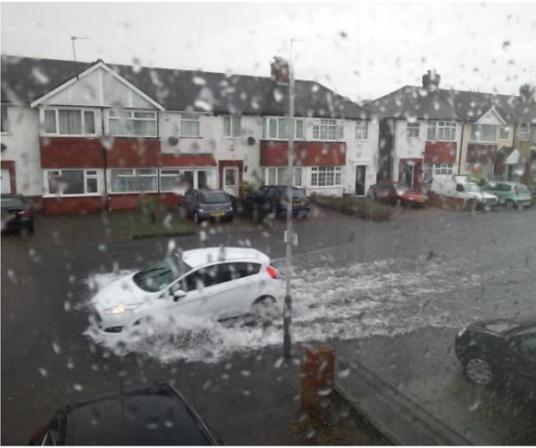
Area affected	b Bedford Road, Clyfford Road and West End Road HA4 6NA	
Date of flooding	28/07/2014	
Grid Reference	509876 185800	
Land ownership	LBH adopted roads and residents	
Map of Area	Photo	
Location of flooding marked as a red star. Blue indicates fluvial flooding and purple surface water taken from EA Flood Maps Red dots indicate Thames Water Surface water sewer outfalls	Taken by residents and provided in Environment Agency Flood Data recording report.

Duration of flooding	Approximately 3 hours	
Source of flooding	Surface Water	
Cause/Pathway	Overwhelming of surface water sewer, water building up in the low points in the roads and spilling out and over the footpaths and into front gardens. Water levels also built up rear of some properties.	
Impact of flooding	Flooding across access roads and in approximately 23 houses	
Evidence	Photos and anecdotal reports from the Get West London. The location is identified on the Environment Agency Flood Map as an area at risk from surface water and fluvial flooding. The area is also within a Critical Drainage Area.

History of flooding	None, although on West End Road there have been previous reports of flooding although more details are not known	
Summary	Heavy rain within a very short period of time overwhelmed the local drains. The London Fire Brigade (LFB) attended the scene on the 28 th July to assist residents. Sandbags provided by LFB to 20 -50 properties affected, some internally.	
Action by the Residents	The Council recommends that where appropriate residents identify what they can do to protect themselves. Products that may help such as air brick covers, with information about them and links to where they can be found on the internet are on the 'flooding' page on Hillingdon website.

<p>Additionally increasing the permeable areas will help reduce the water flowing towards the sewers. Any new front gardens which are paved should comply with GDPO requirements to ensure they are either permeable or drain to a permeable area within the garden.</p> <p>In addition there is concern by residents that the access road to the rear of the properties may be contributing to flooding. These roads are privately owned and the Council holds no information on their current drainage arrangements. Residents need to work together to ensure that the drainage arrangements are maintained by the owner.</p> <p>Every resident should report issues to Thames Water to ensure that the reports they receive reflect the severity of the situation, and the numbers truly affected.</p>
<p>Action by the Council</p>	<p>The Council are responsible for the gullies in an adopted Highway. The gullies are cleaned on a yearly basis by the Council, and are in this area scheduled to be cleaned in approximately August every year. The gullies were cleaned on 4th August 2014. A number of gullies were covered by parked cars and the Highways service returned at a later date to clear these.</p> <p>Where gullies are blocked the debris is removed and the gullies jetted with water to ensure the connections into the sewers are clear. It should be noted that, in heavy rain, leaves and other debris is washed into gullies, blocking them even if they had been previously clear prior to the flood event.</p> <p>The Council has invested in a new system to review the prioritisation of the gullies so that gully clearing could be more frequently to high priority sites less frequent in less critical areas.</p> <p>Council officers have also checked the Thames Water surface water outfalls and found water flow from them to be impeded by silt and vegetation and have reported it to Thames Water to investigate and take action.</p>

<p>Action by Thames Water</p>	<p>Thames Water are responsible for the surface water sewer that gullies drain into. Thames Water visited the site in August on request of residents and undertook a CCTV survey of the surface water sewer. However they were prevented from completing this because the line was blocked. Further work was commissioned by Thames Water for their contractors to undertake a line clean of the surface water sewer. Tree roots which had blocked the line were cut back. Thames Water has said they will monitor the situation and respond to future reports.</p> <p>The Council have requested that Thames Water investigate the whole length of surface water sewer to the point of discharge into a river so that it can be confirmed that the system functions appropriately.</p>
<p>Action by the Environment Agency</p>	<p>The Environment Agency sent out officers to record information on the flood. The council has been provided with the data collected.</p>

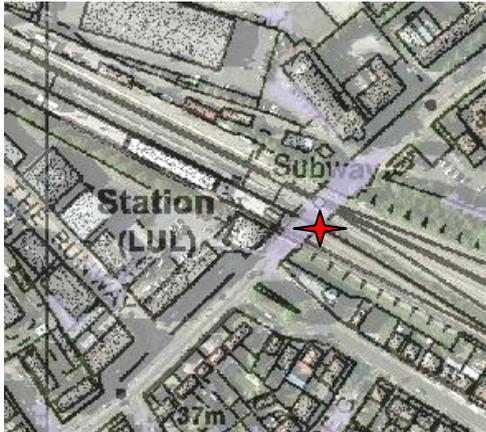
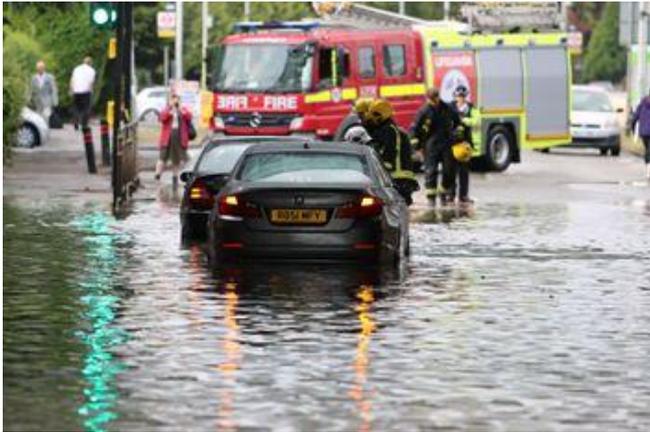
Area affected	c Station Approach, Ruislip HA4 6TP
Date of flooding	28/07/2014
Grid Reference	511149 185418
Land ownership	LBH Adopted Highway
Map of Area	Photo
Location of flooding marked as a red star	Taken by Alan Palmer http://www.getwestlondon.co.uk/news/local-news/two-women-rescued-car-south-7518302

Duration of flooding	Approximately 3 hours
Source of flooding	Surface Water
Cause/Pathway	Overwhelming of surface water sewer
Impact of flooding	Flooding of road and footpath. Two ladies required rescuing.
Evidence	Reports from residents to the Council and news papers. The location is identified on the Environment Agency Flood Map as an area at risk from surface water.
History of flooding	30/11/2009, 11/06/2012, 18/07/2012, 27/10/2013, 5/11/2013, 7/02/2014, 14/05/2014
Summary	2 ladies rescued by LFB on the 28 th July after becoming stranded.
Action by the Council	Council Highways services were called by residents and attended on the 28 th July. They used a tanker to remove water until approximately 4pm when Thames Water arrived. The Council team were able to point out the locations of the blockage. Gullies have been checked previously by the Council on a number of occasions and found to be clear. However a blockage in the surface water sewer was identified. It was reported to Thames Water on numerous occasions by the Council over the last few years, following resident's reports of other issues.

Action by Thames Water	Issue reported by the Council to Thames Water in October 2013. Thames Water have attended site on a number of occasions. Tree roots blocking the pipe were found. Works to clear this had still not been undertaken in July 2014. Road closure is required to enable the dig out of and replacement of the pipe work and replace it, as the blockage cannot be moved.

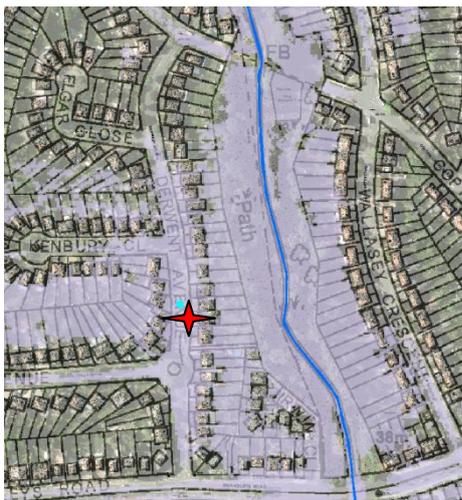
Area affected	d Derwent Avenue, Ickenham UB10 8HJ
Date of flooding	28/07/2014
Grid Reference	507208 186437
Land ownership	LBH adopted Highway
Map of Area	
Location of flooding marked as a red star	none

Duration of flooding	Approx 24 hours.
Source of flooding	Surface Water
Cause/Pathway	Overwhelming of surface water sewer
Impact of flooding	Road flooded, and one home flooded internally
Evidence	Anecdotal evidence from residents. The location is identified on Environment Agency Flood Map as an area where water at risk from surface water.
History of flooding	5 times in 2006, twice previously in 2014
Summary	Surface water flooding from overwhelming of the drains. The Thames Water network drains into the Ickenham stream at the end of Glebe Avenue.
Action by the Council	Gullies that the Council are responsible for are checked on a yearly basis. They have also been checked again following this incident and it was confirmed they are running clear.

Action by Resident	Resident advice to contact Thames Water to confirm there was no capacity issue

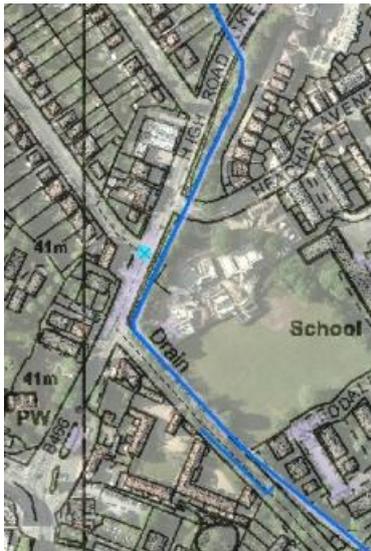
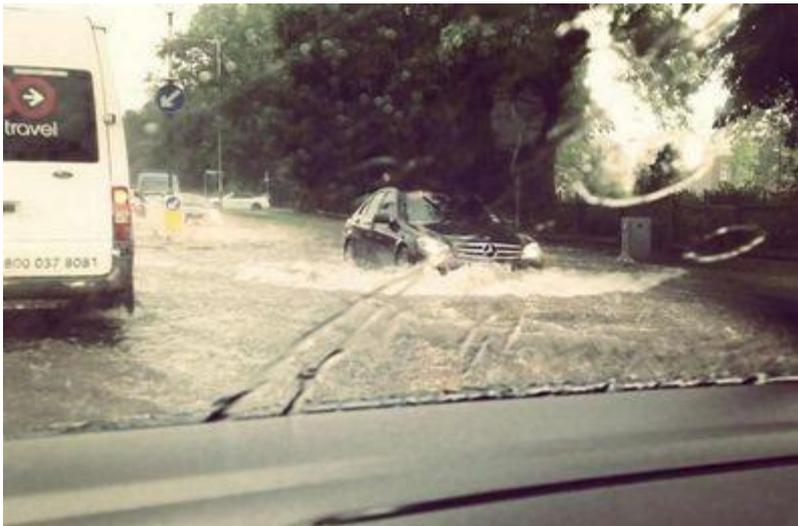
Area affected	e High Road and Austins Lane, Ickenham UB10 8RH	
Date of flooding	28/07/2014	
Grid Reference	508099 186245	
Land ownership	LBH adopted Highway and residents managed by private management company	
Map of Area		
Location of flooding marked as a red star	Photo from Get West London

Duration of flooding	Approx 24 hours.	
Source of flooding	Surface Water and Ordinary watercourse (unconfirmed)	
Cause/Pathway	Unconfirmed presumed to be water not draining away into the Ickenham stream	
Impact of flooding	Road flooded, almost flooding houses on Church Place and Tweedale Grove	
Evidence	Anecdotal evidence from residents. The location is identified on the Environment Agency Flood Map as an area at risk from surface water.	
History of flooding	none	
Summary	Residents tried to report issue to the Council but could not get through, to anyone after a couple of minutes.	
Action by the Council	To investigate maintenance regime of landowner of ordinary watercourse

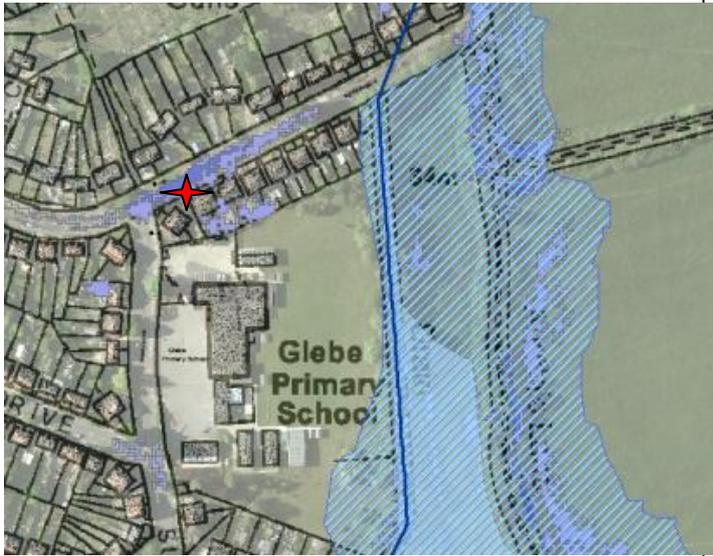
Area affected	f Glebe Avenue, Ickenham UB10 8PQ
Date of flooding	28/07/2014
Grid Reference	508480 185679
Land ownership	Adopted Highway
Map of Area	
Location of flooding marked as a red star

Duration of flooding	Approximately 3 hours
Source of flooding	Surface Water
Cause/Pathway	Highway
Impact of flooding	Flood water flowed across road and into 4 households.
Evidence	Photos and correspondence from residents
History of flooding	1975, 1976 unverified, 1977 flood water entered homes, 1978, 1993, 2006 foul water entered gardens and garages, 2014 flood water entered homes. Identified on the Environment Agency Flood Map for Surface Water as a low lying area.
Summary	Surface water flooding from the overwhelming of the drains, which also caused issues with foul network. The Thames Water network drains into the Ickenham stream at the end of Glebe Avenue.
Action by the Council	<p>Council officers have raised the following issues with other bodies:</p> <ul style="list-style-type: none"> • The need for ongoing maintenance by Thames Water on the surface water sewer main • Maintenance of the Ickenham Stream by the Environment Agency. • The Council have also requested the Environment Agency review their river level monitoring and flood warnings within Hillingdon to see if areas currently not covered can be provided with a warning.

<p>The Council has undertaken the following:</p> <ul style="list-style-type: none"> • Gullies are cleared on an annual basis. • The clearance of the Ickenham stream by contractors has been prioritised to ensure it is flowing properly. Work is scheduled for November/ December 2014.
Action by residents	<p>Ickenham Residents Association are collecting information on future flood events and mapping them and providing that to the Council.</p> <p>The Council recommend that residents draw up a Flood Plan. Further information about this can be found on the Hillingdon website. Also on products to protect houses from flooding through airbricks</p>
Action by Thames Water	<p>Thames Water have attended site since the event on a number of occasions. In November 14 is Glebe Avenue was partially cleared However manhole covers were jammed, so work is proposed to free them.</p>
Action by the Environment Agency	<p>The Environment Agency is funded by DEFRA to undertake maintenance on main rivers. This is focused on high priority areas, and the Environment Agency has advised that, because the Ickenham stream is not at risk from main river flooding, it is not proposed for maintenance by the Environment Agency.</p> <p>No flood warning is issued for the Ickenham Stream.</p>

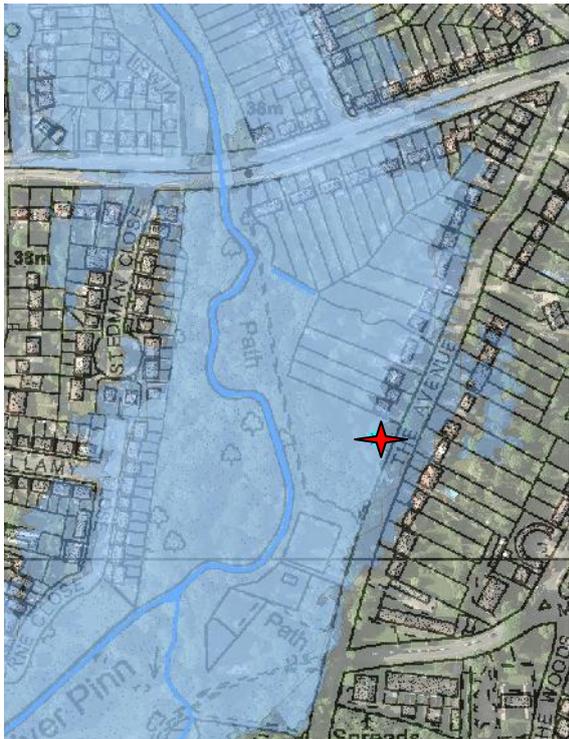
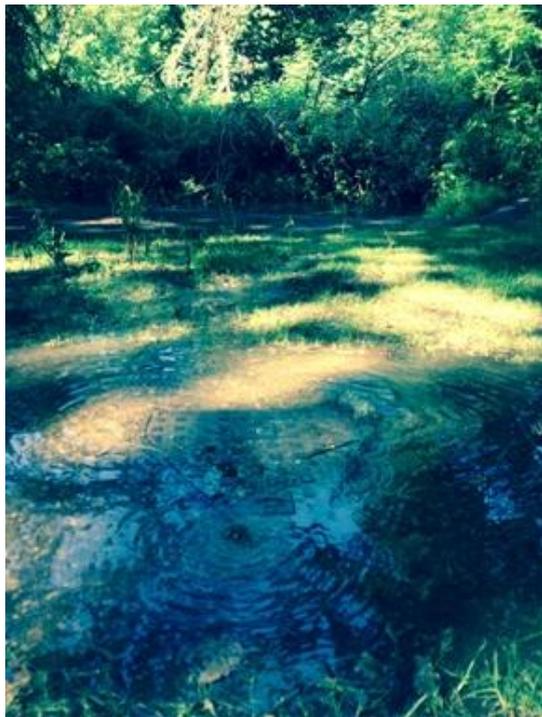
Area affected	g The Avenue, Ickenham UB10 8NR	
Date of flooding	28/07/2014	
Grid Reference	507473 186082	
Land ownership	Residents.	
Map of Area	Photo	
Location of flooding marked as a red star	28 th July 2014 Taken by resident

Duration of flooding	Approximately 3 hours	
Source of flooding	Foul Water	
Cause/Pathway	Unconfirmed	
Impact of flooding	A number of garages and the highway	
Evidence	Anecdotal evidence from the Council and residents.	
History of flooding	none	
Summary	Reports from residents regarding the foul sewer flowing into the River Pinn.	
Action by Thames Water	Reported to Thames Water by residents Reference 0081/03SGWZ. CCTV survey shows fractures in the pipe which needs to be resolved. Works ongoing.

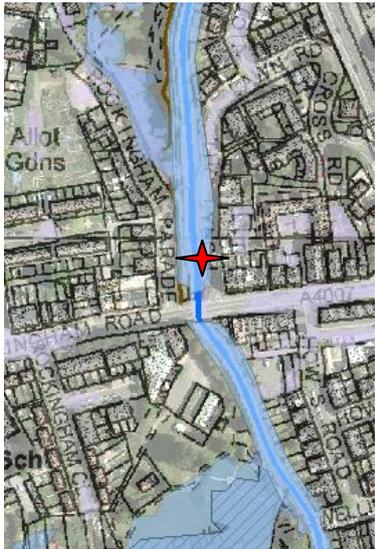
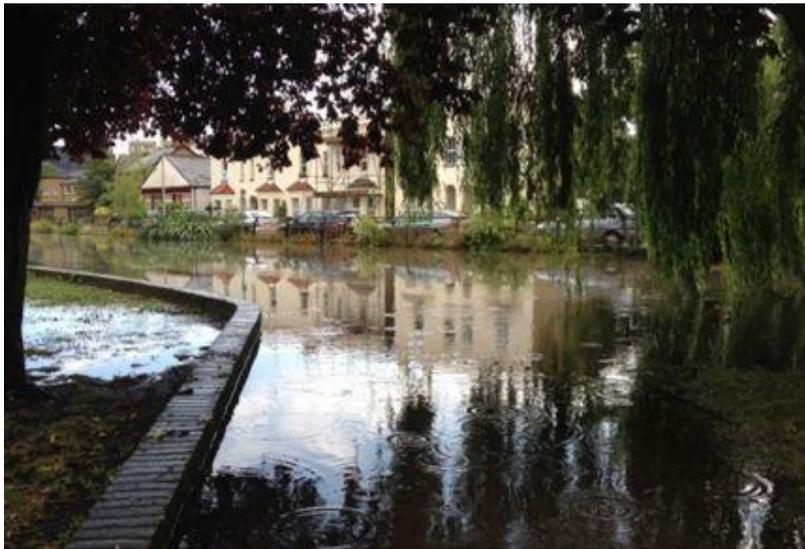
Area affected	h Rockingham Parade and The Lynch, Uxbridge UB82TQ	
Date of flooding	28/07/2014	
Grid Reference	505379 183540	
Land ownership	Adopted Highway	
Map of Area	Photo	
Location of flooding marked as a red star. Blue indicates fluvial flooding shown on Flood Zones	Taken by Steve Terrill GET West London http://www.getwestlondon.co.uk/news/local-news/in-pictures-flooding-hits-hillingdon-7518585

Duration of flooding	Approximately 3 hours	
Source of flooding	River Colne	
Cause/Pathway	The River Colne water levels rose due to the amount of rain falling, and a Flood Alert was issued for the area by the Environment Agency at 10:43am	
Impact of flooding	Flood water flowed across the road and into front gardens. Unverified reports of flooding through airbricks.	
Evidence	Photos and reports from residents	
History of flooding	None, but identified as being within an area at risk of fluvial flooding on the Environment Agency Flood Map.

Summary	River levels were high	
Action by the Council	Continued monitoring of the situation	
Action by the residents	The Council recommend residents draw up a Flood Plan. Further information can be found on the Hillingdon website. Also on products that can be purchased to protect homes from flooding through airbricks.

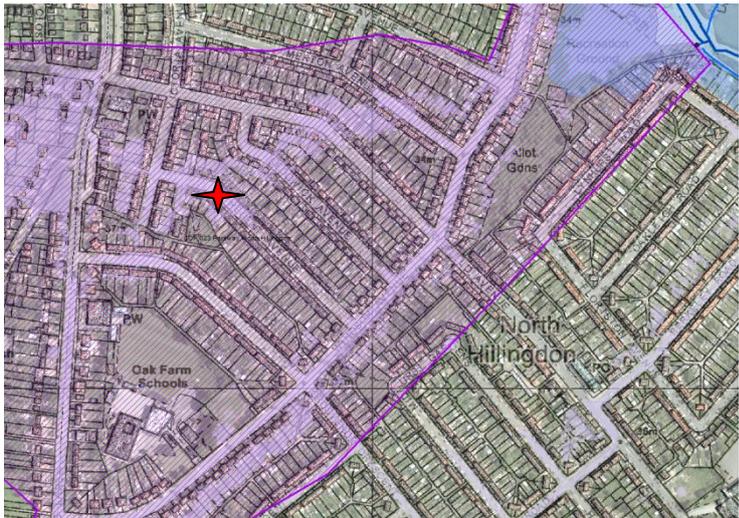
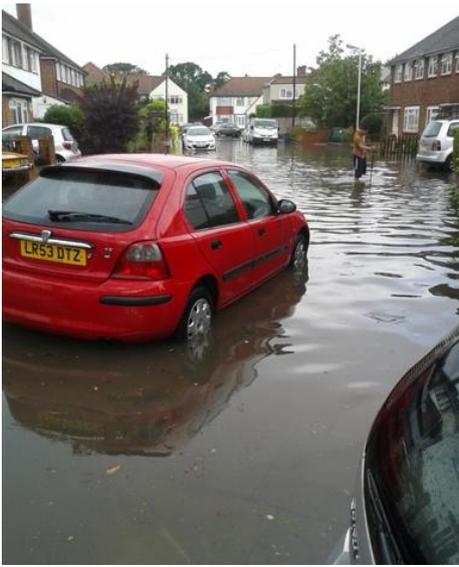
Area affected	i Regents Avenue and Windsor Avenue Uxbridge UB10 9AT	
Date of flooding	28/07/2014	
Grid Reference	508193 184513	
Land ownership	Adopted Highway	
Map of Area	Photo	
Location of flooding marked as a red star, purple hatching defines the critical drainage area, with shaded purple the areas likely to be at risk from surface water	Taken by resident

Duration of flooding	Approximately 3 hours	
Source of flooding	Surface Water	
Cause/Pathway	Water built up in the road flowing over footpaths into front gardens and into some homes.	
Impact of flooding	Flood water flowed across the road and into front gardens and in some cases; this resulted in houses being flooded internally.	
Evidence	Photos and reports from residents. The area is also within a Critical Drainage Area identified by the SWMP	
History of flooding	None, but identified as within an area at risk of surface water flooding on the Environment Agency Flood Map.

Summary	Flood water built up and flowed into houses very quickly	
Action by the Council	To record the event, and refer to Thames Water	
Action by the residents	The Council recommend residents draw up a Flood Plan. Further information can be found on the Hillingdon website. Also on products that can be purchased to protect homes from flooding through airbricks.

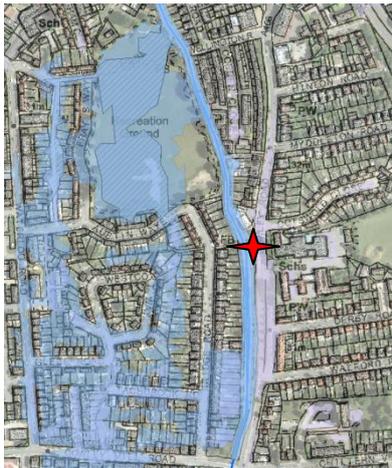
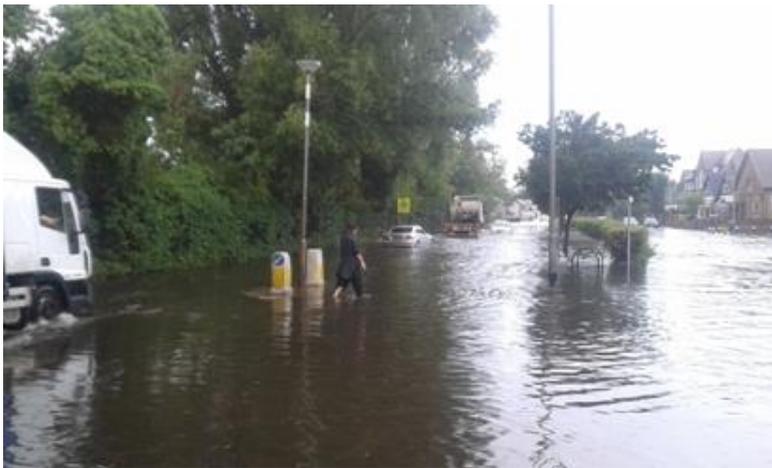
Area affected	j Cowley Road, Uxbridge UB8 2LT	
Date of flooding	28/07/2014	
Grid Reference	505376 183544	
Land ownership	Adopted Highway	
Map of Area	Photo	
Location of flooding marked as a red star	Taken by London Borough of Hillingdon Officer

Duration of flooding	Approximately 3 hours	
Source of flooding	Surface Water	
Cause/Pathway	Overwhelming of surface water sewer by heavy rain.	
Impact of flooding	Cowley Road closed to buses, with tailbacks and diversions	
Evidence	<p>Cowley Road Uxbridge 28th July 2014 - YouTube</p> <p>▶ 0:27 ▶ 0:27</p> <p>www.youtube.com/watch?v=DHOWfN27zY0</p> <p>1 day ago - Uploaded by Nigel Clark</p> <p>Uxbridge Cowley Road flood rain</p>	
History of flooding	None, but identified as being within an area at risk of surface water flooding on the Environment Agency Flood Map.	
Summary	Lower River Colne and Fray's River. Flood Alert issued by the Environment Agency. The River Colne rose above the level of Thames Water pipes discharging water from the road into the river. This meant that water could not drain away quickly, so that it built up in the road until the water level in the river fell again.

Action by the Council	Gullies checked to ensure they are clear.

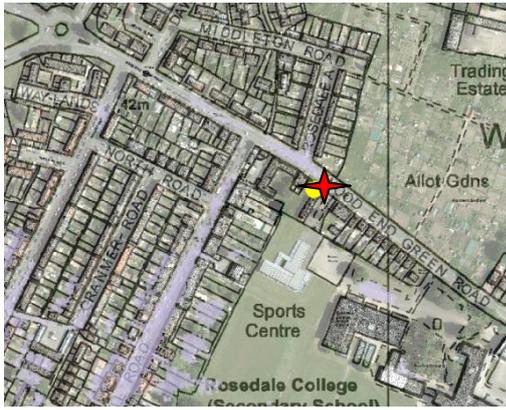
Area affected	k Wood End Green Road UB3 2SF	
Date of flooding	28/07/2014	
Grid Reference	508946 181496	
Land ownership	Adopted Highway	
Map of Area	Photo	
Location of flooding marked as a red star	none

Duration of flooding	Approximately 3 hours	
Source of flooding	Surface Water	
Cause/Pathway	Water built up in the road flowing over footpaths into front gardens	
Impact of flooding	Flooding of the road	
Evidence	Reports from residents	
History of flooding	Consistently reoccurring issue 23/11/2014, 04/11/2014, 19/08/2014 28/07/2014. Identified as an area at risk of surface water flooding on the Environment Agency Flood Map.	
Summary	Flood water built up very quickly	
Action by the Council	<p>To continue yearly clearance of gullies. Gullies last checked on the 8th October 2014.</p> <p>To continue raising the issue with Thames Water. To provide residents with information on how to dispose of fats and grease - This can be found on the Hillingdon website.</p>

Action by Thames Water	<p>Thames Water have attended site on a number of occasions to clear both the foul and surface water sewer.</p> <p>Thames Water to send out literature on the proper disposal of fats and grease as this had blocked the foul sewer.</p>	
Action by the residents	<p>To dispose of fats and grease appropriately.</p> <p>The Council recommend residents draw up a Flood Plan. Further information can be found on the Hillingdon website. Also on products that can be purchased to protect homes from flooding through airbricks.</p> <p>To continue to report all issues to Thames Water.</p>

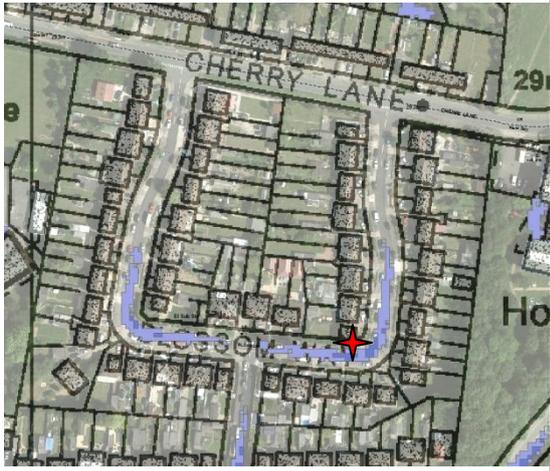
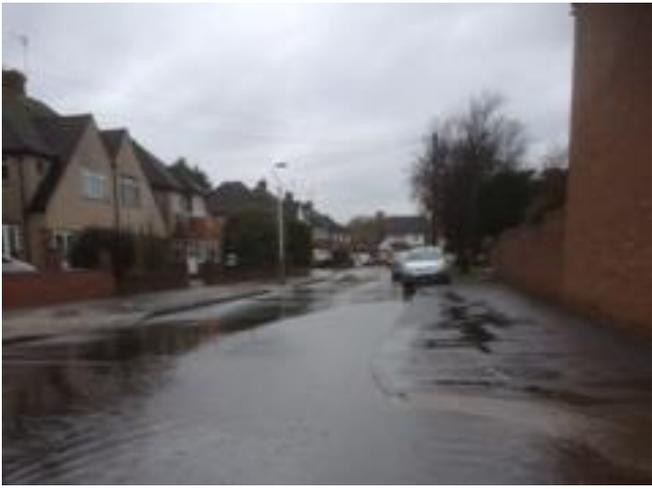
Area affected	I Blossom Way, West Drayton UB7 9HG	
Date of flooding	28/07/2014	
Grid Reference	507162 178683	
Land ownership	LBH Adopted Road	
Map of Area	Photo	
Location of flooding marked as a red star	Photo taken by resident and sent to the Council

Duration of flooding	Approximately 3 hours	
Source of flooding	Surface Water	
Cause/Pathway	Highway	
Impact of flooding	Road flooded for a number of hours	
Evidence	Photos and correspondence with residents	
History of flooding	Flooding reported by residents in Jan 2014. The area is also identified within an area at risk of surface water flooding on the Environment Agency Flood Map for Surface Water.	
Summary	Water ponding on the road was not able to drain away into the soakaways as they were full. A recurring issue.	
Action by the Council	There are no Thames Water surface water sewers in this road. All the drainage currently goes to a soak away in the verge. The Council considered a number of options and has created a new soak away to reduce the extent of flooding. However it should be noted there will be more extreme events which may overwhelm this system.
